DEPARTMENT OF TRANSPORTATION

Contract #: 04-0120F4Cty: SF/ALA Rte: 80 PM: 13.2/13.9File #: 1.28**WELDING INSPECTION REPORT****Resident Engineer:** Casey, William**Address:** 333 Burma Road**City:** Oakland, CA 94607**Report No:** WIR-029024**Date Inspected:** 23-Jan-2013**Project Name:** SAS Superstructure**OSM Arrival Time:** 700**Prime Contractor:** American Bridge/Fluor Enterprises, a JV**OSM Departure Time:** 1730**Contractor:** American Bridge/Fluor Enterprises, a JV**Location:** Job Site**CWI Name:** See below.**CWI Present:** Yes No**Inspected CWI report:** Yes No N/A**Rod Oven in Use:** Yes No N/A**Electrode to specification:** Yes No N/A**Weld Procedures Followed:** Yes No N/A**Qualified Welders:** Yes No N/A**Verified Joint Fit-up:** Yes No N/A**Approved Drawings:** Yes No N/A**Approved WPS:** Yes No N/A**Delayed / Cancelled:** Yes No N/A**Bridge No:** 34-0006**Component:** OBG**Summary of Items Observed:**

WELDING INSPECTION REPORT

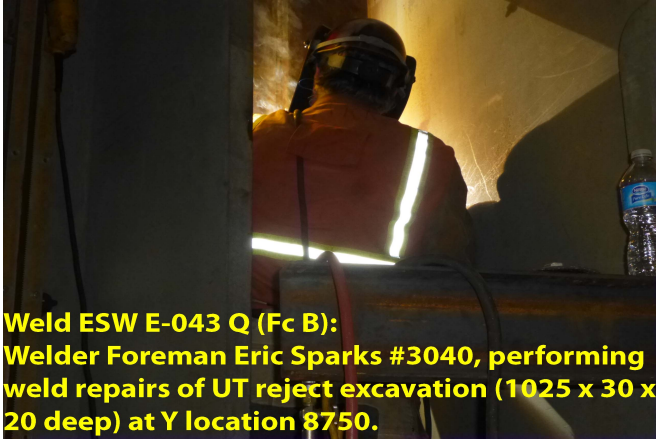
Welder was observed performing weld repairs to weld ESW E-043 Q at Face B, in way of the excavation 1025 x 30 x 20 deep at Y location 8750. The weld was preheated to 300 degrees Fahrenheit with the Miller Pro Heat induction blankets prior to welding. Welder was observed utilizing Welding Procedure Specification (WPS) ABF-WPS-D15-1000-Repair Rev.3 for Shield Metal Arc Welding (SMAW) as per Request for Weld Repair or

RWR 201301-038. Welding parameters were verified by QC Inspector William Sherwood throughout the day and appear to be in compliance with the WPS noted above.

**Weld ESW E-043 Q (Fc B):
Welder Foreman Eric Sparks #3040, performing
weld repairs of UT reject excavation (1025 x 30 x
20 deep) at Y location 8750.**
